DUCK CREEK STATE WILDLIFE REFUGE - POND 2
STODDARD COUNTY, MISSOURI
MISSOURI INVENTORY NO. 40093

PHASE I INSPECTION REPORT
NATIONAL DAM SAFETY PROGRAM

Anderson Engineering, Inc., Springfield, Missouri
Hanson Engineers, Inc., Springfield, Illinois

December, 1980

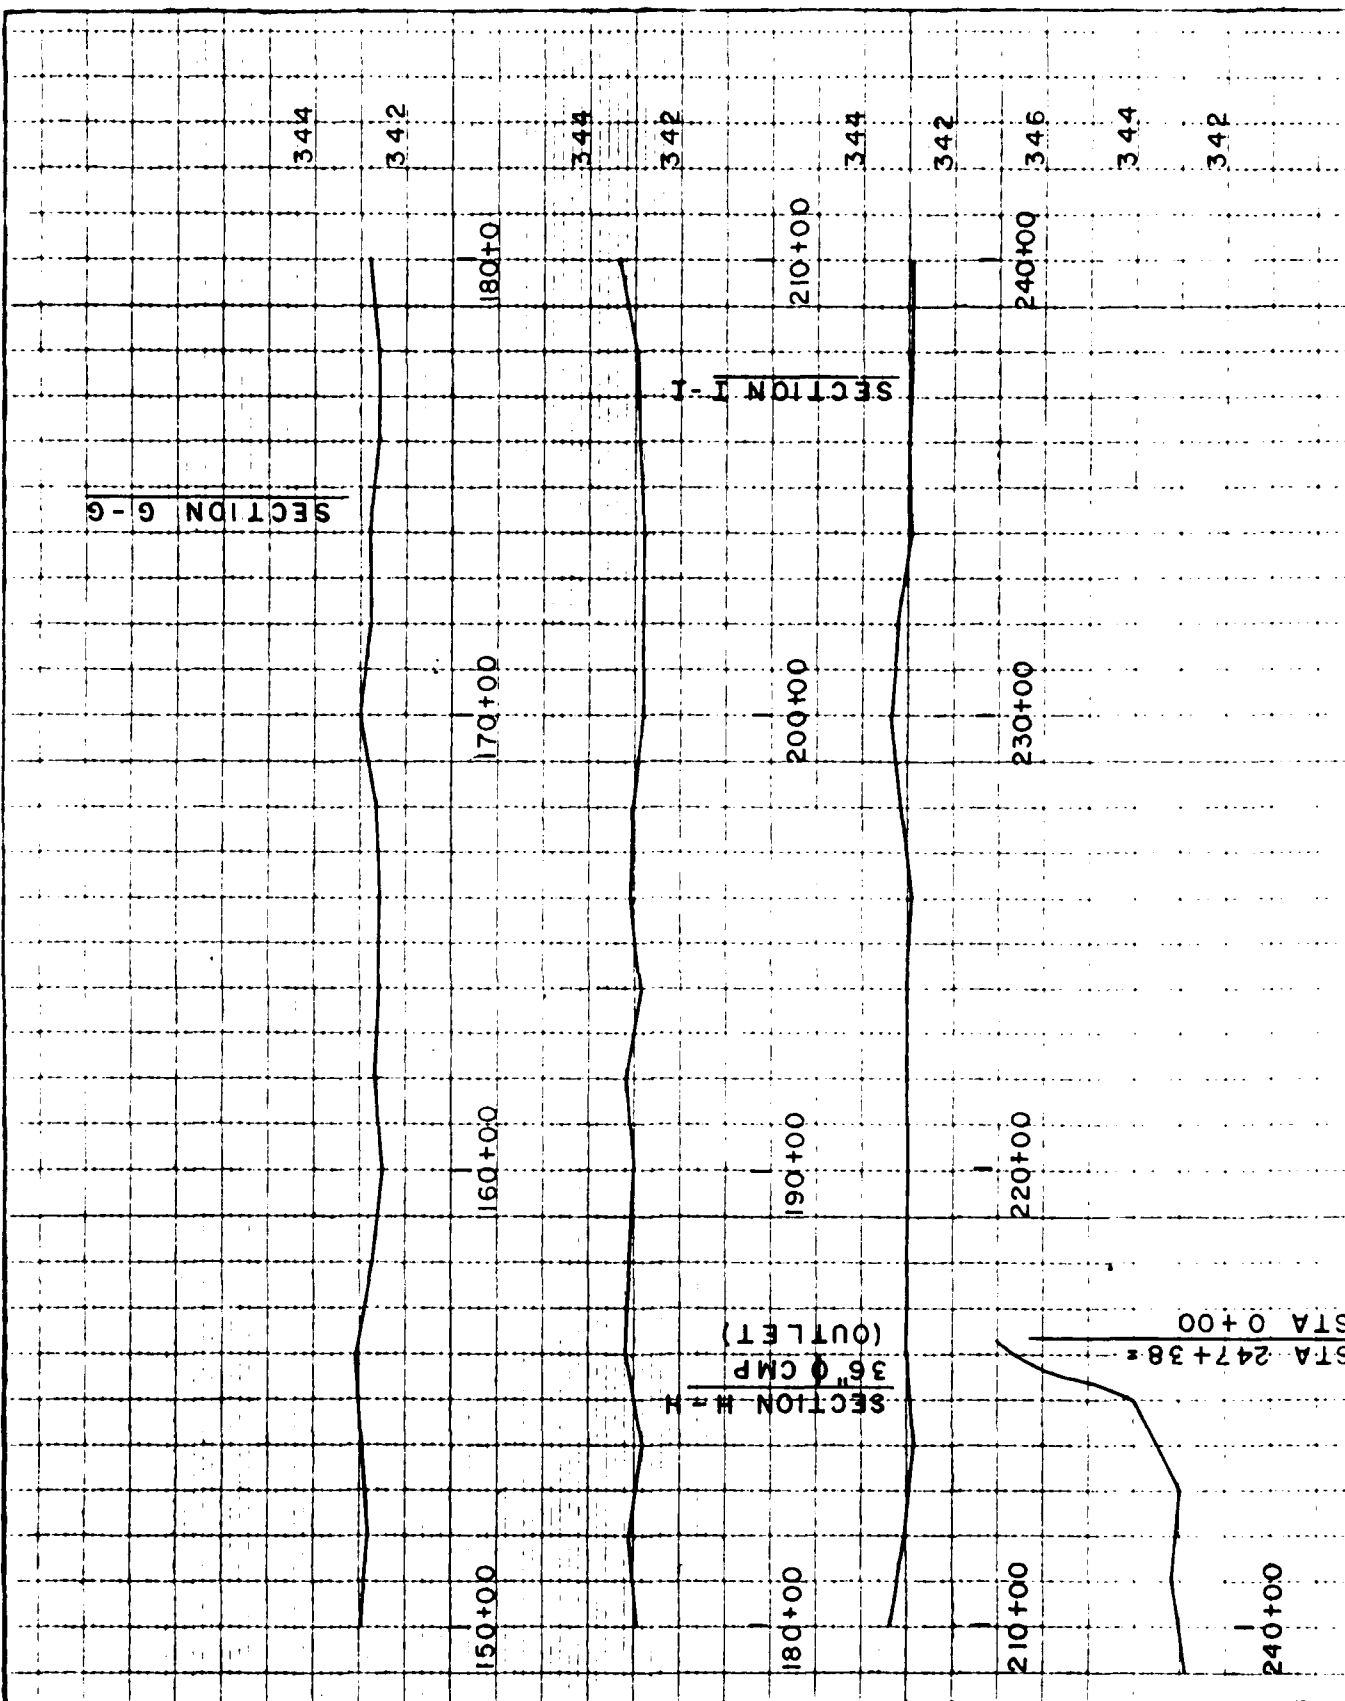
DUCK CREEK STATE WILDLIFE REFUGE #2
STODDARD COUNTY, MISSOURI
MO. I.D. No 40093
PROFILE

The vertical alignment of the crest was generally good, with some irregularities of the profile observed (See Sheets 4 and 5 of Appendix A).
